# STRUCTURE NO. 00705

ROUTE 15  
over  
RIPPOWAM RIVER  
STAMFORD

Routine Inspection  
on  
5/12/2009

**Connecticut Department of Transportation**  
**Bridge Inspection Report BRI-18**

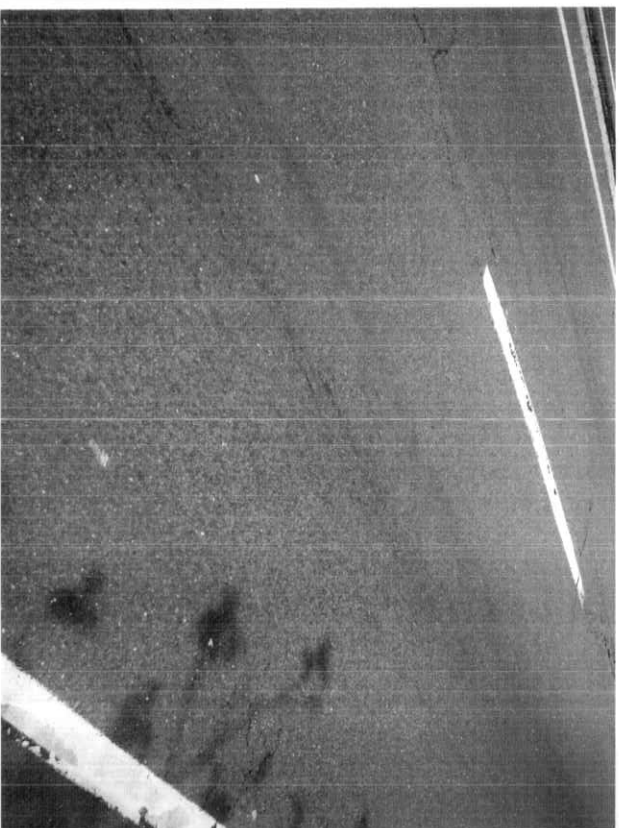
OVERLAY	<b>6</b>	Bituminous over Ballast: exhibits longitudinal, random and transverse cracking, some open up to 1" wide. Centerline paving seams are open with some raveling, and has one adjacent spall 1' dia upto 3" deep.
DECK STR. CONDITION	<b>N</b>	Overall rating is based on the condition of the wearing surface when the deck is integral with the superstructure.
CURBS	<b>5</b>	Concrete curbs/safety walks: exhibit areas of severe scale, transverse cracks and spalls.
MEDIAN	<b>7</b>	MBR: exhibits minor dents leaning posts and areas of very light rust.
SIDEWALKS	<b>N</b>	See curbs.
PARAPET	<b>5</b>	Stone Masonry: exhibits a +/- 10' long x 2' wide section which is bowed out +/- 3" near the top at the northeast corner, minor to moderate mortar voids and some loose and cracked mortar.
RAILING	<b>N</b>	
PAINT	<b>N</b>	
FENCE	<b>N</b>	
DRAINS	<b>N</b>	
LIGHTING STANDARD	<b>N</b>	
UTILITIES TYPE/SIZE	<b>N</b>

**Photo #2 :**  
**General view of wearing surface N/B**

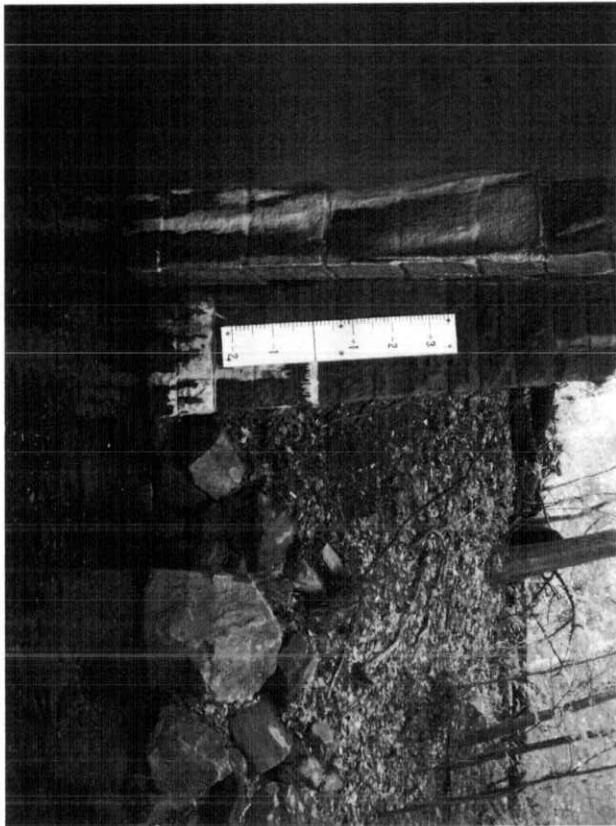
Bridge ID painted on parapets. High water monitoring gauge mounted to the northwest wing at the interface of the arch ring.

**Photo #7:**  
**Stream gauge at inlet**

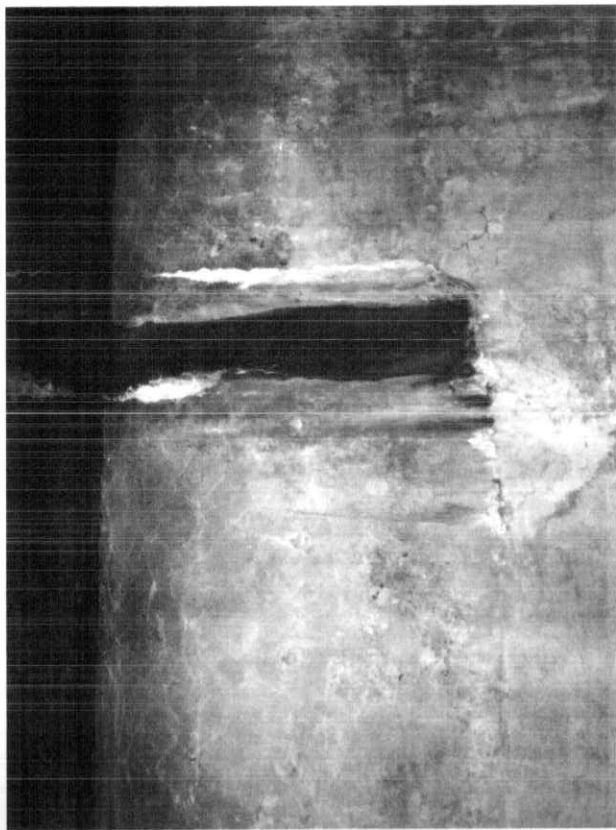
**Photo #8:**  
**Spall with active leakage stem 1**

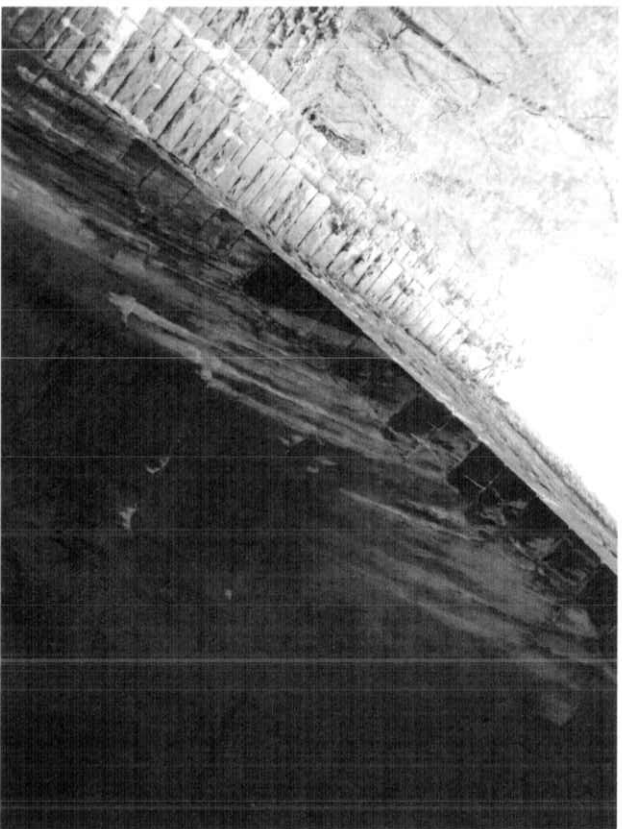
**Photo # 9:**

BEARING DEVICES	<b>N</b>	
STRINGERS	<b>5</b>	Intrados : exhibits.. Heavy efflorescence and active leakage at the interface of the intrados and the arch ring. A +/- 15' long diagonal crack with efflorescence and active leakage at the northwest corner. Hairline map cracking at random locations. Pop-outs with exposed rebars (rusted) at random locations. A spall with exposed rusted rebar with a small adjacent hollow area on the lower northwest corner. Exposed rusted shallow rebar along the construction joint on the east side. D shape potential spall adjacent to construction joint.

**Cracks with efflo. on inter face north side**
